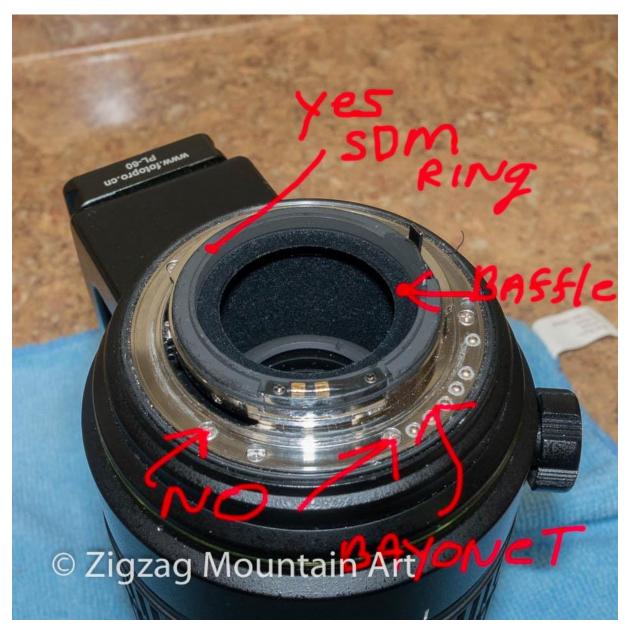
1. First, there is no need to remove the bayonet. Just the smaller plastic ring that holds the SDM contacts.

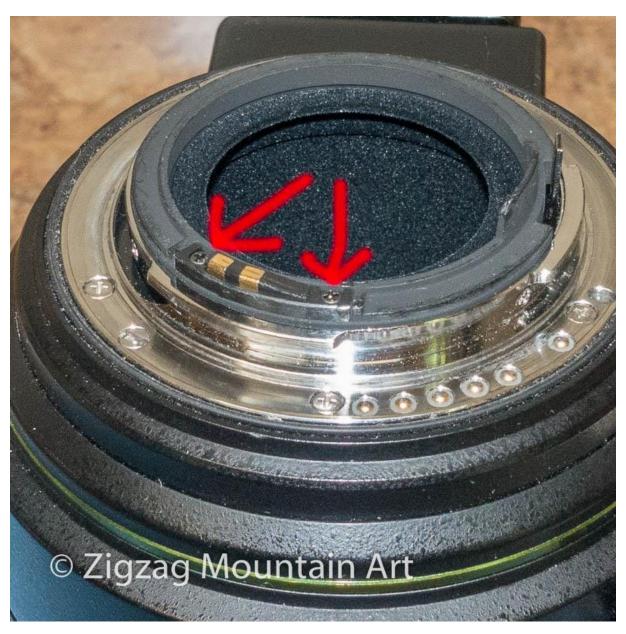
2. Locate the SDM contacts and remove the two small black screws there.

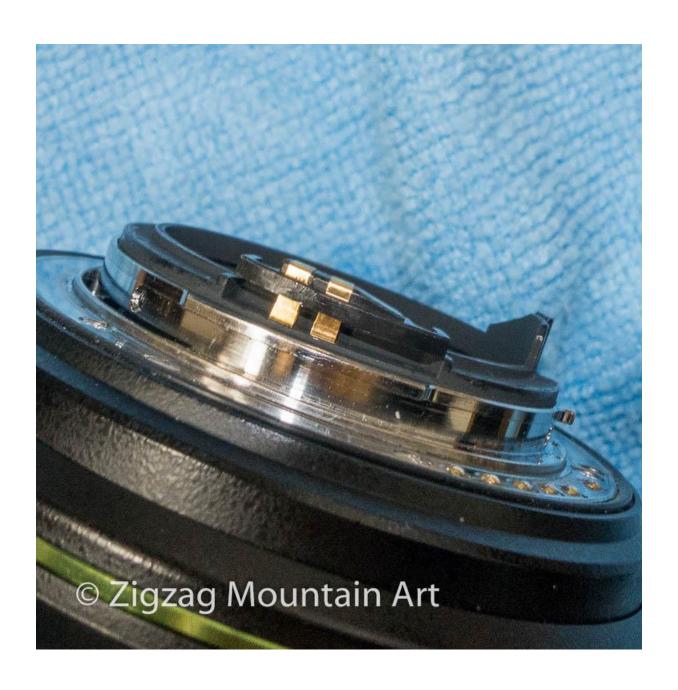
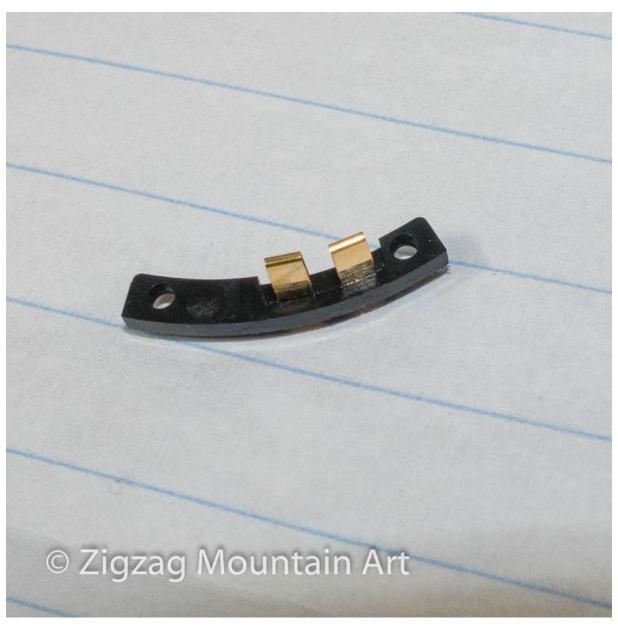
3. Gently pry out the black plastic SDM mount with the two gold contacts. These are slip fit connectors, like electrical connectors, so just gently pry on each side back and forth until it lifts out.

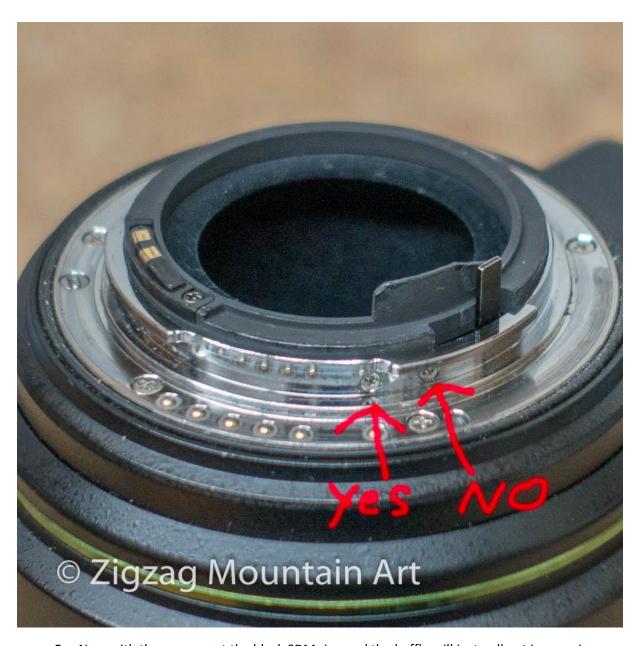
4. Locate the three silver screws holding the black ring in place. There are four screws in the ring. Three located at 120 degrees from each other and a fourth just to the right of one of the others. Of the pair you want the left one. Remove these three screws. I used a rear lens cap to put the pieces in to keep them safe. These are very small screws. They are also JIS so make sure you do not strip them.

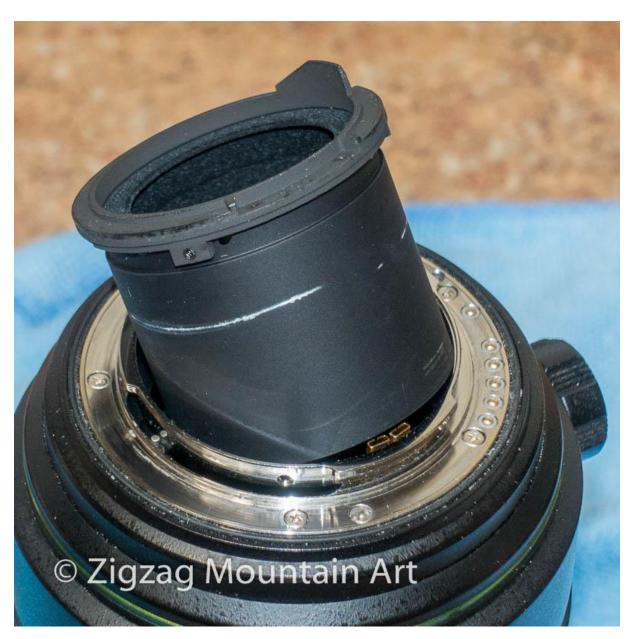
5. Now with the screws out the black SDM ring and the baffle will just pull out in one piece.

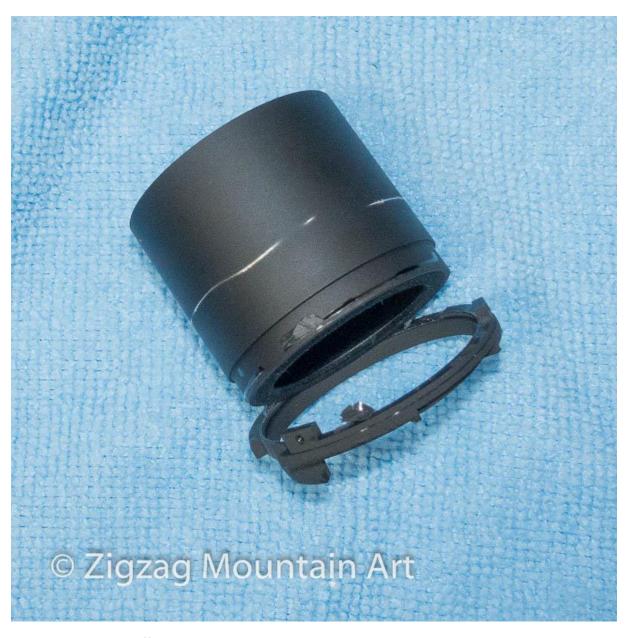
6. The baffle is glued with something like rubber cement to the SDM ring. I used an Exacto razor knife to cut the glue away, but it was soft enough I think you could just break it. Note the scratches on the black baffle, these were present on the baffle when I removed it and were not caused by anything I did. Not sure if they are from manufacturing or if something was rubbing on it inside.

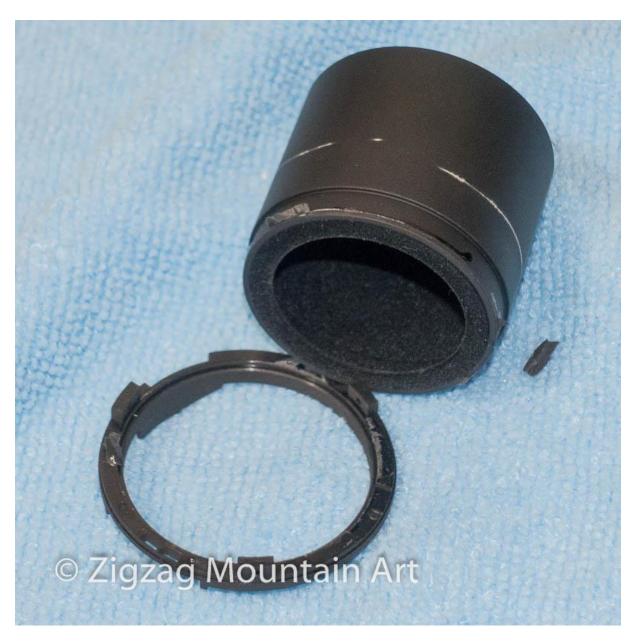
7. Now the baffle and the SDM ring are seperated, clean up any glue residue on the ring. I just used the razor knife.

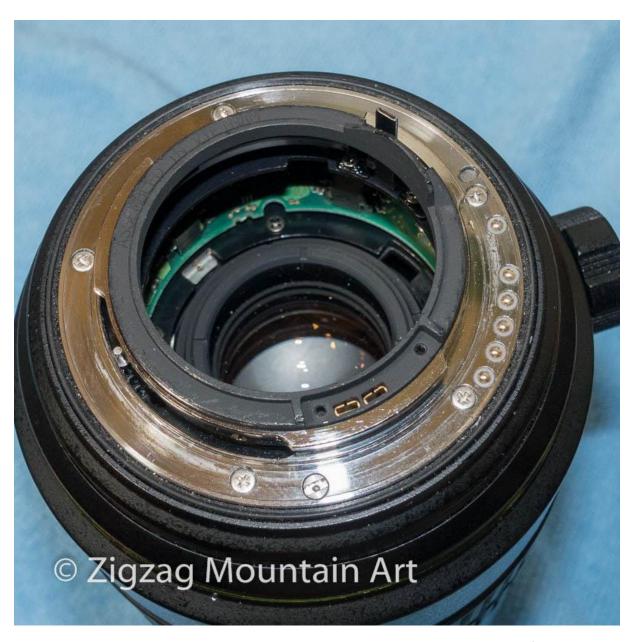
8. Now we need to remount the SDM ring. Place the ring back in position, aligning the two rectangular holes with the two gold female SDM contacts. Replace the three silver screws.

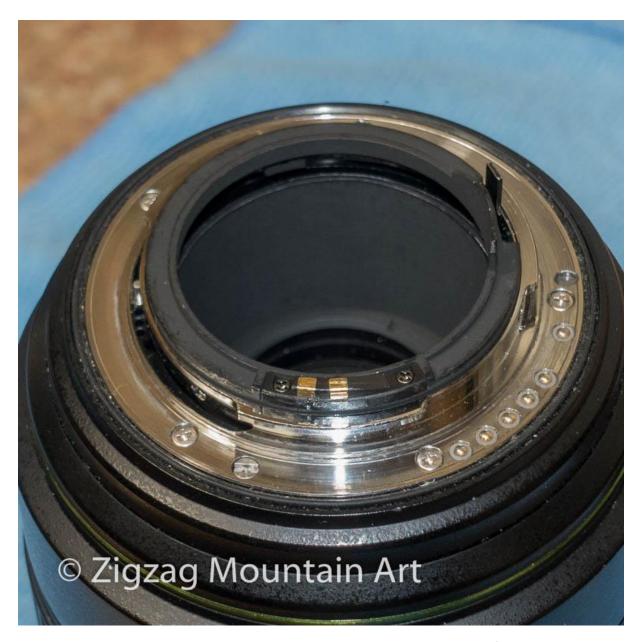
- 9. Now gently replace the SDM contacts by pressing them slowly back into the female connectors. Replace the two black screws that hold the SDM contact plate in place.
- 10. Now insert the cardboard replacement baffle. Dimensions of the original are roughly 30mm wide so you need a cardboard strip a bit smaller than that and long enough to wrap around itself. I just rolled it up slightly tighter than needed, inserted it and let it unroll in place.

After brief testing I can say that most, but not all of the, vignette has been removed. Unfortunately it is dark and overcast today so difficult to do good testing. From what I see there is no vignette below 85mm and only a slight darkening in the corners above that. This is at f/4. The sharp circular vignette is completely gone and I do not think the lens is much worse in the corners now on FF than it was on APS-C
