GLASER®

Practical Information

Composite Cylinder-head Gaskets and Damage Analysis Multi-layer Steel (MLS) Cylinder-head Gaskets and Component Surfaces MLS Cylinder-head Gaskets and Damage Analysis Cylinder-head Bolts and Cylinder Head Installation PTFE Oil Seals and their Installation

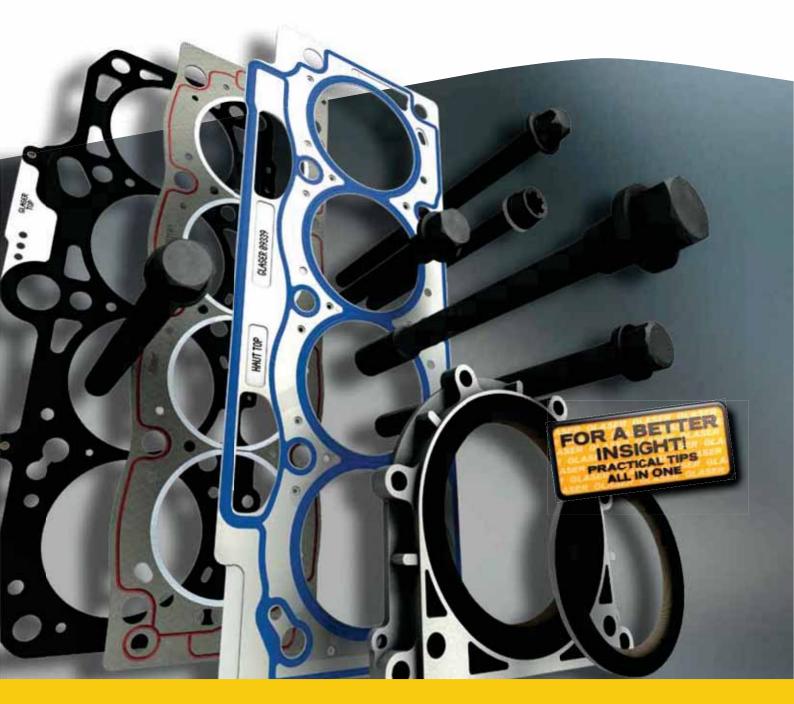
Classical composite head gasket with tanged metal carrier sheet, composite material rolled onto both sides, impregnation, fire rings, and Viton element.

The classical composite head gasket is a compressible flat gasket. It consists of a tanged metal carrier sheet, onto which the composite material is rolled on both sides, i.e. engine block and cylinder head. Metal beads (fire rings) seal the combustion chamber and protect the sensitive composite material from overheating. The material surface is impregnated to prevent the gasket swelling when it comes in contact with liquid media such as oil, water, or antifreeze. So-called Viton elements of elastomer materials permit a partial increase of mounting surface pressure in the vicinity of oil pressure channels.

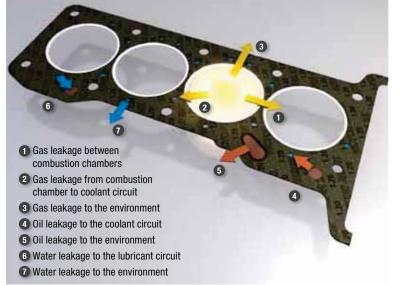
Typical media leakages with composite cylinder head gaskets.

In total, seven different types of media leakage can occur with composite head gaskets:

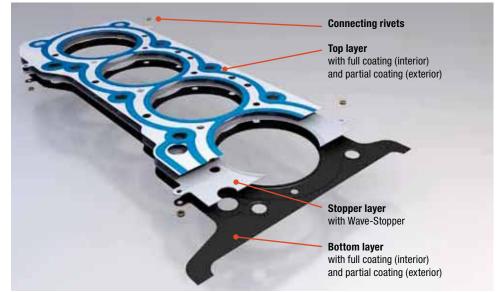
Typical 3-layer MLS head gasket with top sheet, active layer with Wave-Stopper, and bottom sheet beads plus full-surface (interior) and partial (exterior) elastomer coatings improve the sealing potential of these modern sealing systems. Beads for macro sealing, and elastomer coating for micro sealing.

MLS head gaskets consist of two to five sheets of spring or carbon steel, which are sandwiched with the sealing material to form multilayer steel head gaskets. For improved sealing of gases and liquids, beads around combustion chambers and oil/coolant passages increase the local sealing pressure (macro sealing), whilst full-surface or partial elastomer coatings provide additional sealing tightness (micro sealing).

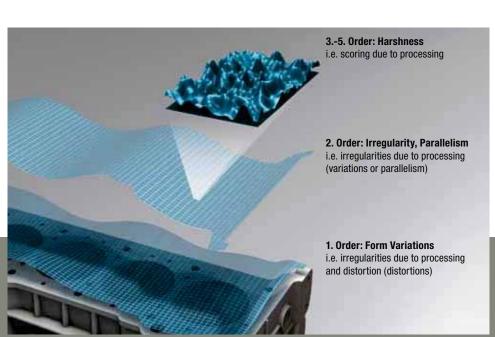
Example of influences of surface quality due to surface deviations on an engine block.

The following surface deviations lead to reduced surface qualities of cylinder head and engine block:

- ¬ Component unevenness
- ¬ Component distortion
- ¬ Waviness (deviations in parallelism)
- ¬ Roughnesses (grooves and scores)

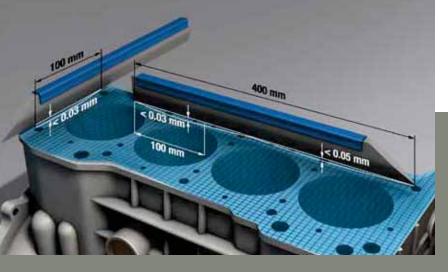
Maximum values for component unevenesses and distortions for passenger cars. Practical measurement using a straightedge and the light-gap method.

Component unevenness and distortion can be determined by means of a straightedge. Measurements are made using the light-gap method. The edge of the test device is placed on the surface, and moved over the bolt holes longitudinally and transversely. Hereby, any unevennesses are made visible by the light gap.

- Component unevenness for passenger cars
 less than 0.03 mm over a longitudinal distance of 100 mm;
 less than 0.05 mm over a longitudinal distance of 400 mm;
 less than 0.03 mm over a transverse distance of 100 mm
- **¬ Component unevenness for commercial vehicles**less than 0.03 mm over a longitudinal distance of 100 mm;
 less than 0.10 mm over a longitudinal distance of 1,000 mm;
 less than 0.03 mm over a transverse distance of 100 mm
- ¬ Waviness less than 20 μm
- ¬ Roughness between 7 μm and 20 μm

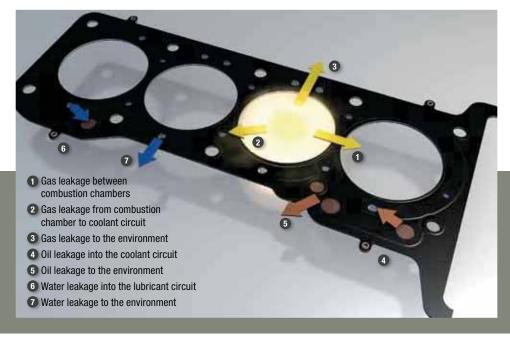
Typical media leakages with MLS cylinder-head gaskets

Typical leaks between cylinder head, cylinder-head gasket, and engine block involve gas, oil, or coolant leakages. These leakages occur between combustion chambers, into the coolant circuit, or to the environment. Gas leaks can result in fatal engine damage within a very short time and oil leaks can cause severe environmental pollution.

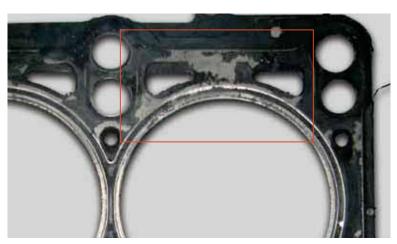
▲ Elastomer coating damaged by overheating

Classical causes for overheating are defects of the water pump, radiator, thermostat or hoses, but also insufficient coolant or incorrect venting of the coolant system can lead to thermal problems. Failure of the catalytic converter can also result in higher temperatures due to increased exhaust back pressure.

If the elastomer coating of a removed defective cylinder-head gasket can be peeled off the metal substrate easily with a fingernail, engine overheating is the most likely cause of the failure.

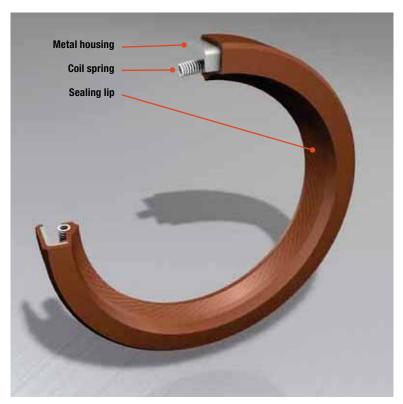
▲ Construction of a conventional oil seal with spring ring.

The purpose of oil seals is to provide sealing between the rotating crankshaft and the outside. Classical oil seals consist of a metal housing that carries the dynamic sealing lip and also provides the static sealing function. The sealing lip of oil seals is usually manufactured of elastomer material, and is in contact with the surface of the rotating shaft. Hereby, the lip is pressed onto the shaft surface by means of a spring ring. As a result of the rotational movement, there is a sealing gap of approx. 1 µm at the lip edge. Oil can enter this gap, which serves to lubricate the sealing lip.

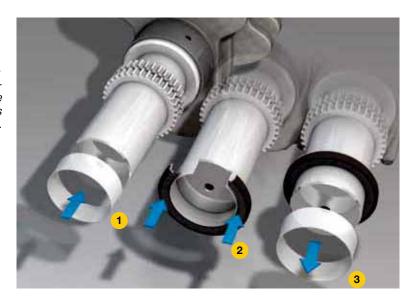
As opposed to the installation of conventional oil seals, certain particularities must be observed during the installation of oil seals with PTFE sealing lip.

- Only remove PTFE oil seals from their protective packaging immediately before installation, to protect them from dust and other contamination.
- The sealing lip of PTFE oil seals is protected by a plastic sleeve, which can normally be used as an assembly aid. Therefore, the sleeve should remain in place until the seal has been installed.
- If the seal is to be installed without the sleeve, use the special tool provided by the manufacturer.

- 4. Both the PTFE sealing lip and the shaft surface must be completely dry. Do not use any grease or oil.
- 5. The shaft may not exhibit any sharp-edged chamfers if necessary, have the edges removed by an engine expert.
- The shaft surface must be in a perfect condition – also here, possible damage must be repaired by an expert.
- 7. Position the assembly sleeve with the PTFE oil seal on the shaft.

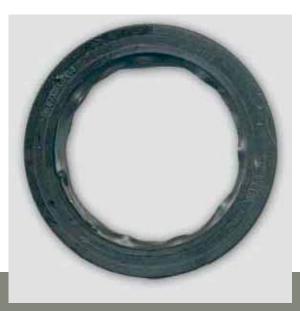
▲ Damaged PTFE sealing lip as the cause of failure.

▲ Greased PTFE sealing lip as the cause of failure.

The most frequent cause for failure is damage to the PTFE sealing lip during assembly. If the seal is installed without the help of a sleeve or special tool, and is shifted or even turned inside out, reliable sealing will hardly be possible. Similarly, the use of oil or grease – as with classical oil sealing rings – will result in total failure of the PTFE oil seal immediately after installation.
